Contract #: 04-0120F4Cty: SF/ALA Rte: 80 PM: 13.2/13.9File #: 69.28**WELDING INSPECTION REPORT****Resident Engineer:**Siegenthaler, Peter**Address:** 333 Burma Road**City:** Oakland, CA 94607**Report No:** WIR-022152**Date Inspected:** 22-Mar-2011**Project Name:** SAS Superstructure**OSM Arrival Time:** 1500**Prime Contractor:** American Bridge/Fluor Enterprises, a JV**OSM Departure Time:** 300**Contractor:** Zhenhua Port Machinery Company, Ltd (ZPMC), Changxing Island **Location:** Shanghai, China**CWI Name:** Mr. Liu Huajie**CWI Present:** Yes No**Inspected CWI report:** Yes No N/A**Rod Oven in Use:** Yes No N/A**Electrode to specification:** Yes No N/A**Weld Procedures Followed:** Yes No N/A**Qualified Welders:** Yes No N/A**Verified Joint Fit-up:** Yes No N/A**Approved Drawings:** Yes No N/A**Approved WPS:** Yes No N/A**Delayed / Cancelled:** Yes No N/A**Bridge No:** 34-0006**Component:** BAY14 OBG**Summary of Items Observed:**

WELDING INSPECTION REPORT

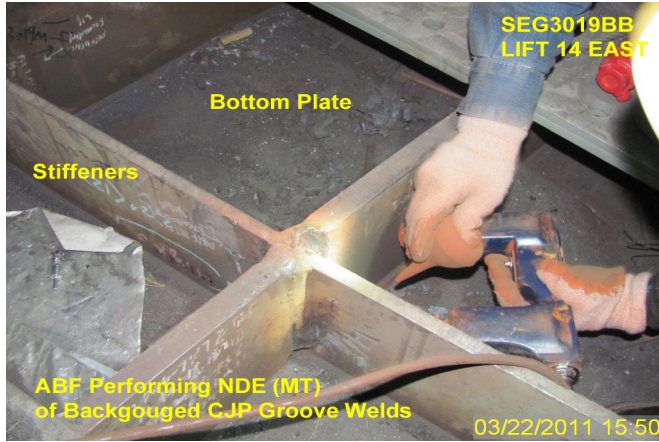
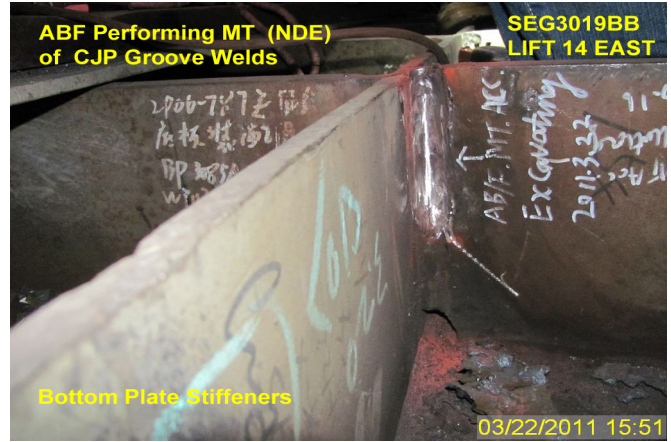
SMAW welding of complete joint penetration weld joint(s) located on lift 14E, SEG3019BB Vertical Shear Plate to Anchor Plate weld number(s) 089. Welder is identified as welder no. 216086. The welding variables recorded by ZPMC QC identified as Wang Xiang Pin appeared to comply with applicable WPS(s)
WPS-B-P-2212-TC-U4b-FCM-1.

SMAW welding of complete joint penetration weld joint(s) located on lift 14E, SEG3019BB Vertical Shear Plate to Anchor Plate weld number(s) 133. Welder is identified as welder no. 215553. The welding variables recorded by ZPMC QC identified as Wang Xiang Pin appeared to comply with applicable WPS(s)
WPS-B-P-2212-TC-U4b-FCM-1.

SMAW welding of complete joint penetration weld joint(s) located on lift 14E, SEG3019BB Vertical Shear Plate to Anchor Plate weld number(s) 155. Welder is identified as welder no. 044779. The welding variables recorded by ZPMC QC identified as Wang Xiang Pin appeared to comply with applicable WPS(s)
WPS-B-P-2212-TC-U4b-FCM-1.

SMAW welding of complete joint penetration weld joint(s) located on lift 14E, SEG3019BB Vertical Shear Plate to Anchor Plate weld number(s) 177. Welder is identified as welder no. 054013. The welding variables recorded by ZPMC QC identified as Wang Xiang Pin appeared to comply with applicable WPS(s)
WPS-B-P-2212-TC-U4b-FCM-1.

FCAW welding of complete joint penetration weld joint(s) located on lift 14E, SEG3019AA Longitudinal Diaphragm to Bottom Plate weld number(s) 025. Welder is identified as welder no. 067079. The welding variables recorded by ZPMC QC identified as Wang Xiang Pin appeared to comply with applicable WPS(s)
WPS-B-T-2231-ESAB and B-CWR2755.

FCAW welding of complete joint penetration weld joint(s) located on lift 14E, SEG3019E-2 Floor Beam Stiffener to Longitudinal Diaphragm weld number(s) 147 and 151. Welder is identified as welder no. 051356. The welding variables recorded by ZPMC QC identified as Wang Xiang Pin appeared to comply with applicable WPS(s)
WPS-B-T-2231-ESAB and B-CWR2862.
